HO- 980  
Knock-Franklin Farm  
15681 Old Frederick Road  
Lisbon vicinity

# Maryland Historical Trust Maryland Inventory of Historic Properties Form

Inventory No. HO-980

historic Knock-Franklin Farm

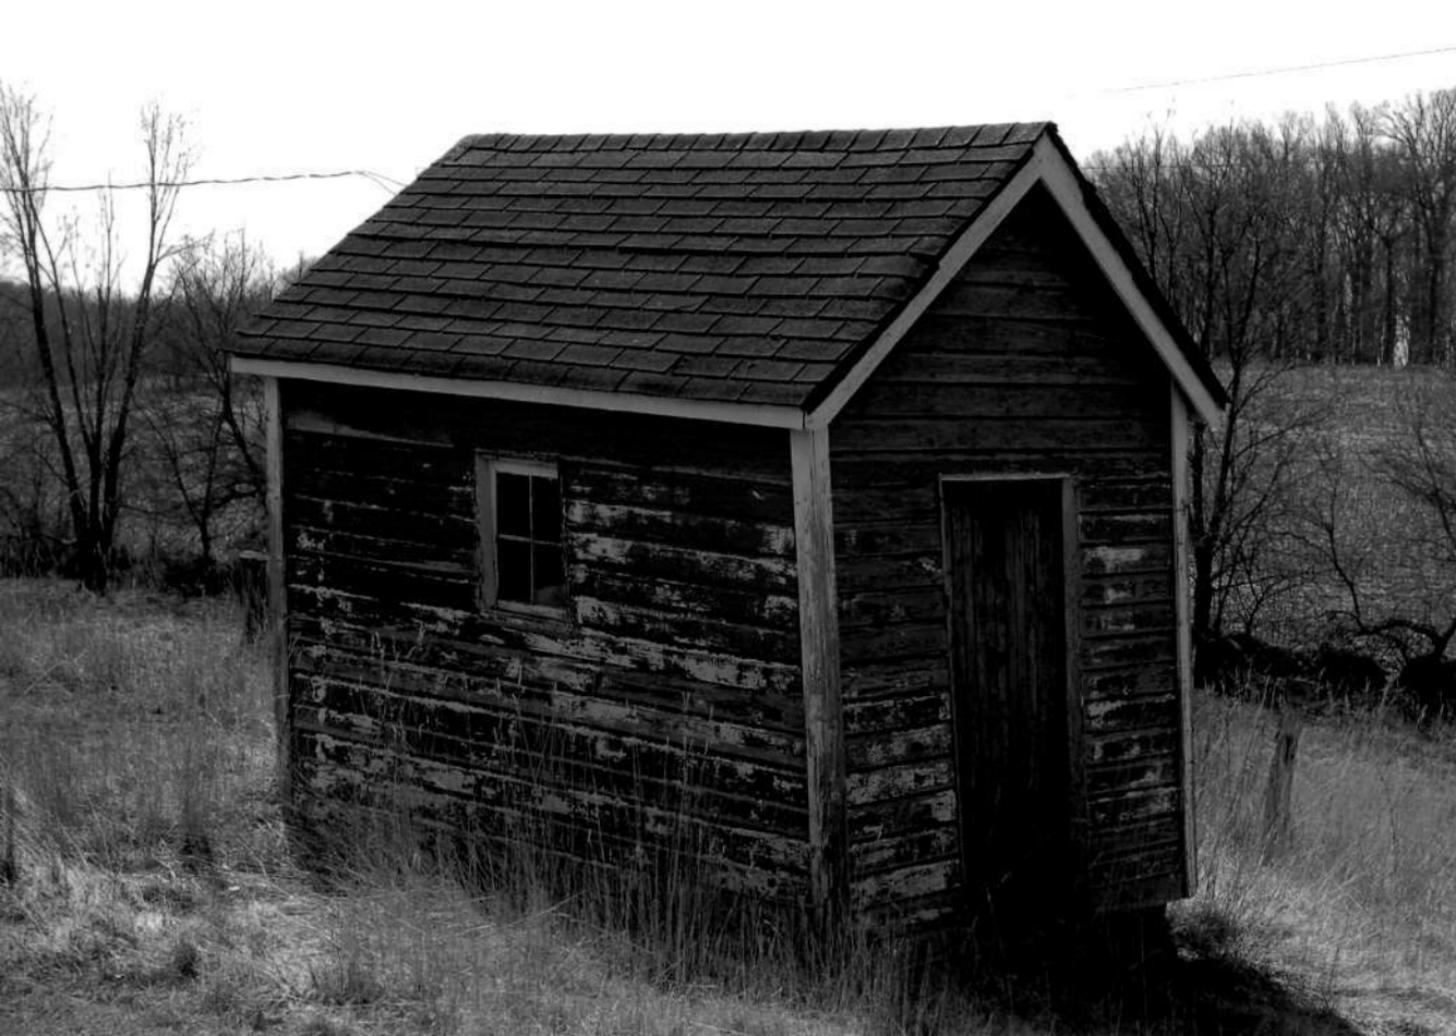
13 of 14

The workshop is located about 30 feet southeast of the barn and is a one-story, one-bay square structure with concrete foundation, German siding, and a gable roof with asphalt shingles and a northwest-southeast ridge. The northwest elevation has a V-groove vertical-board door, the northeast elevation has a four-light sash, the southwest elevation also has a four-light sash, and the southeast elevation has no openings. There are open eaves with fascia boards. The building is constructed of circular-sawn 2 by 4s throughout. There is a workbench on the northeast side of the interior. The sash are mortised and tenoned and pinned at the corners.

Workshop, northeast + northwest  
elevations

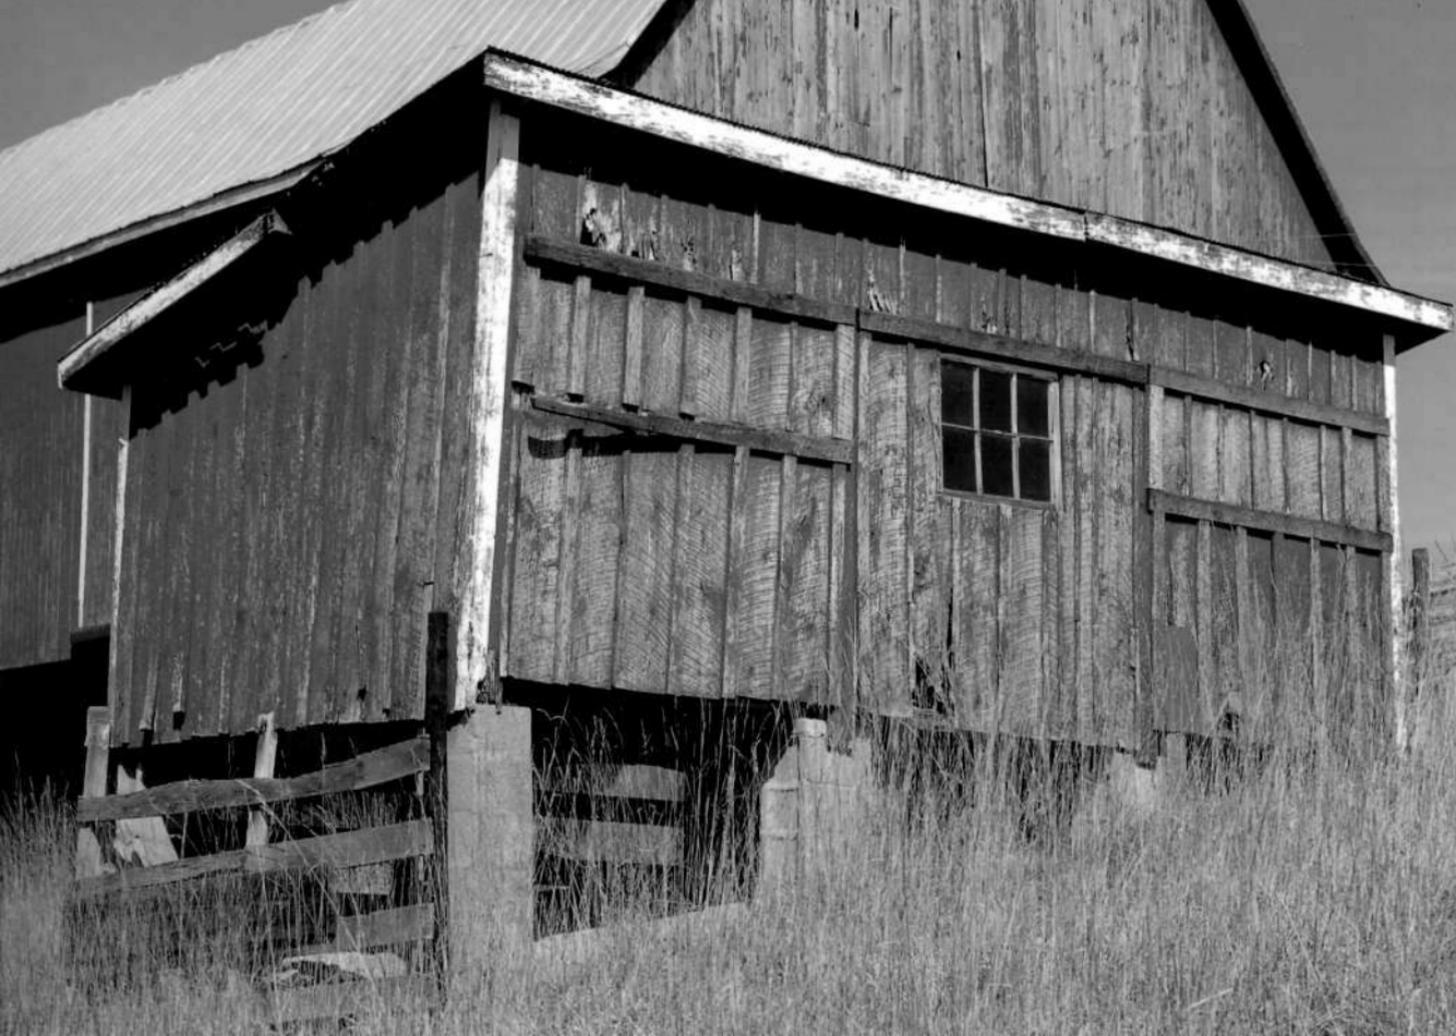
14 of 14

The chicken house is about 25 feet south of the barn and is a one-story, three-bay by one-bay frame structure on CMU piers. It is set on a hill that slopes down to the southwest. There is board-and-batten siding that is circular-sawn and a shed roof that slopes down to the northwest and has corrugated metal. There is a six-light sash in the center of the southeast elevation and a vertical board door on the northeast, set to the east. The southwest and northwest elevations have no openings. This building is of 2 by 4 construction.

Chicken house southwest &  
southeast elevations
